City of Valdosta

Sanitary Sewer Condition Assessment and Rehabilitation Program Plan

Condition and Criticality Report

January 2010

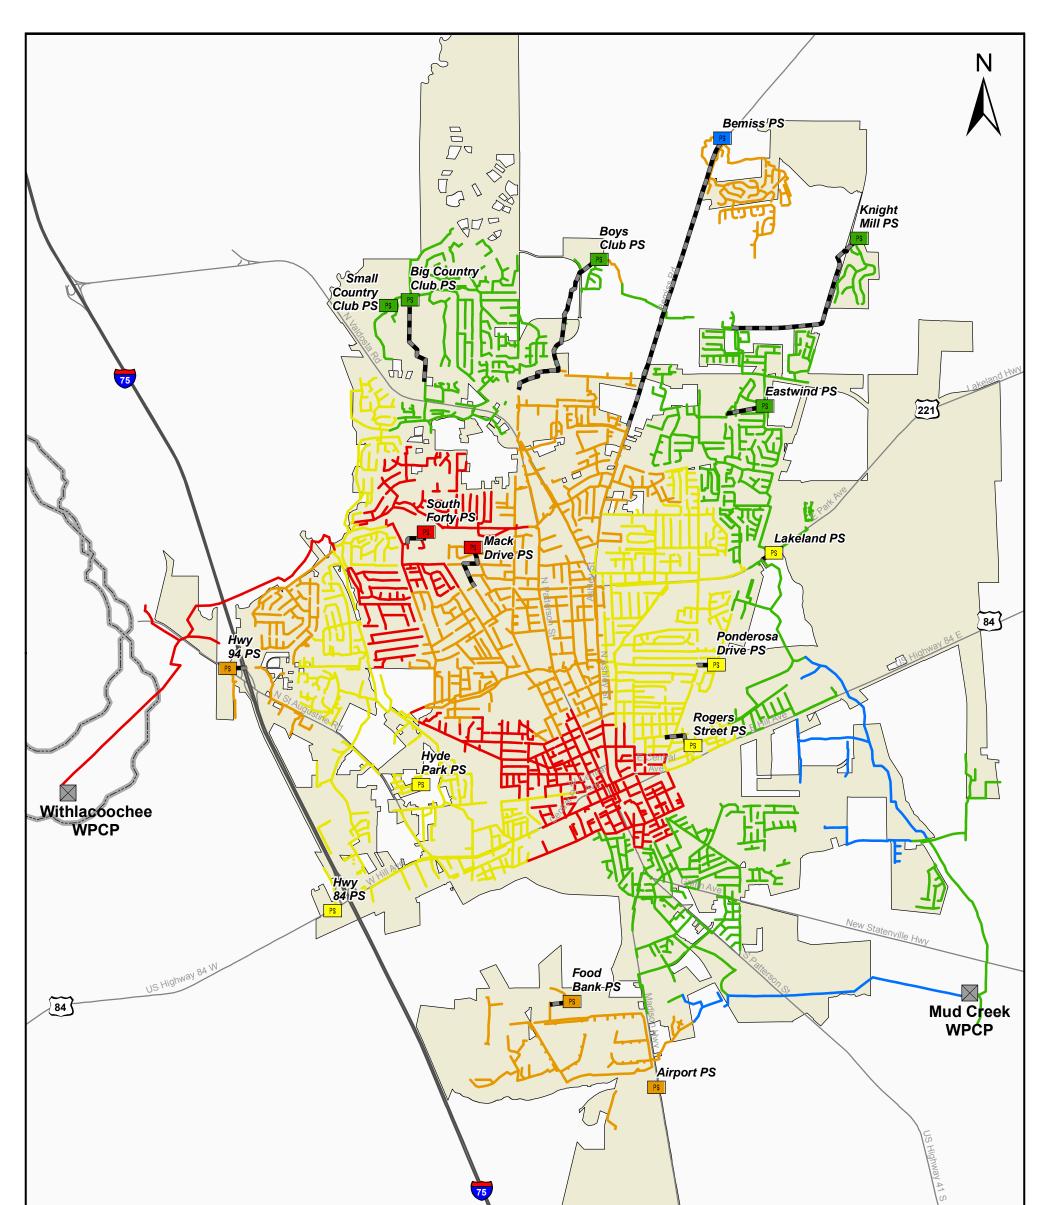
Figure 2-12 City of Valdosta Sewer Collection System Inflow & Infiltration Levels

Figure 2-12 shows the levels assigned for the inflow/infiltration condition factor. Areas with the highest I/I levels include portions of the gravity sewers tributary to the upper West Dukes Bay, Browns Canal, Sugar Creek, Two Mile and Withlacoochee outfalls. I/I factor level of five was assigned to the Withlacoochee outfall for a number of reasons. During the course of the flow monitoring period, the velocity sensor in Meter 14 on the Withlacoochee outfall showed unusual readings, but site conditions prohibited corrective maintenance from being performed. During the first two maintenance visits, the manhole in which Meter 14 was installed showed high levels of hydrogen sulfide gas which prohibited entry into the manhole.

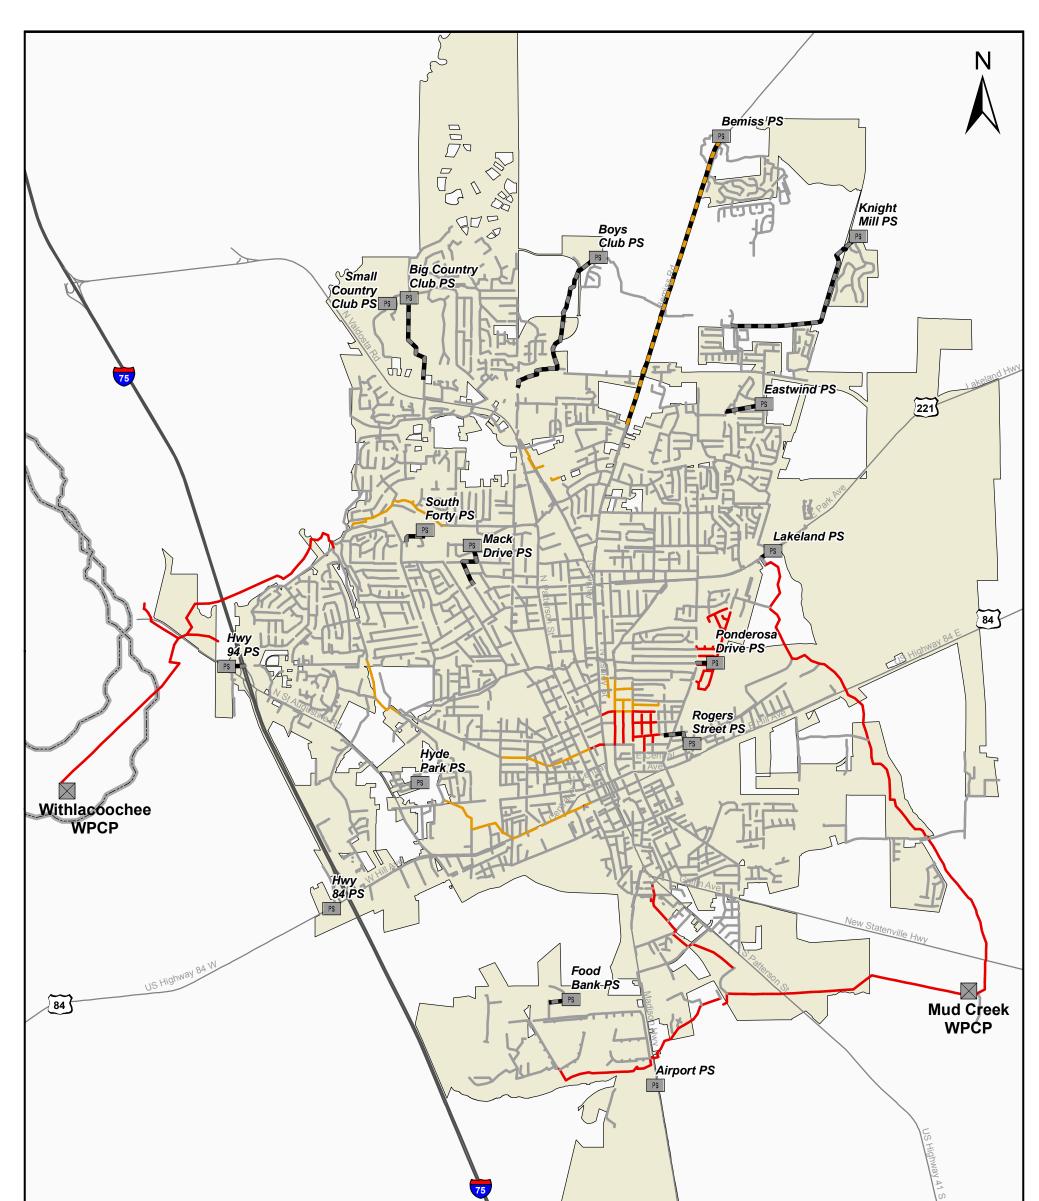
Figure 2-13 City of Valdosta Sewer Collection System Areas of Concern Levels

The South Dukes Bay outfall Meter 19 recorded surcharging 43 percent of the time. This surcharging, in combination with high peak flows, indicates the potential for excessive infiltration entering the collector sewer or along the outfall upstream of the meter. The capacity evaluation indicated a hydraulic restriction which may be causing much of the surcharge and stagnant water and is further discussed in Section 5.

The Mud Creek outfall Meter 20 recorded surcharging 55 percent of the time. The downstream Meter 21 did not record the same level of surcharging and thus was

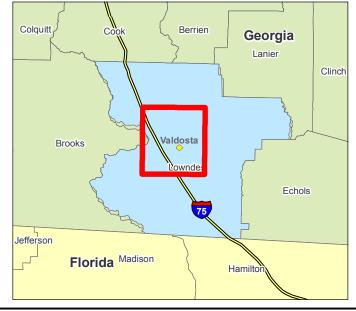
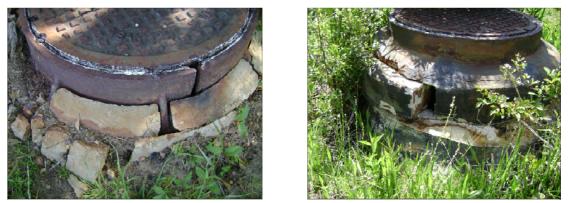
Field visits to Knights Creek outfall showed some manhole rims in poor condition and some portion of the sewer passing under

Manholes on Knights Creek Outfall in Poor Condition
