4.2 Cherry Creek & Stillhouse Branch 4.2.1 Introduction

4.2.2 Sub-basin Information

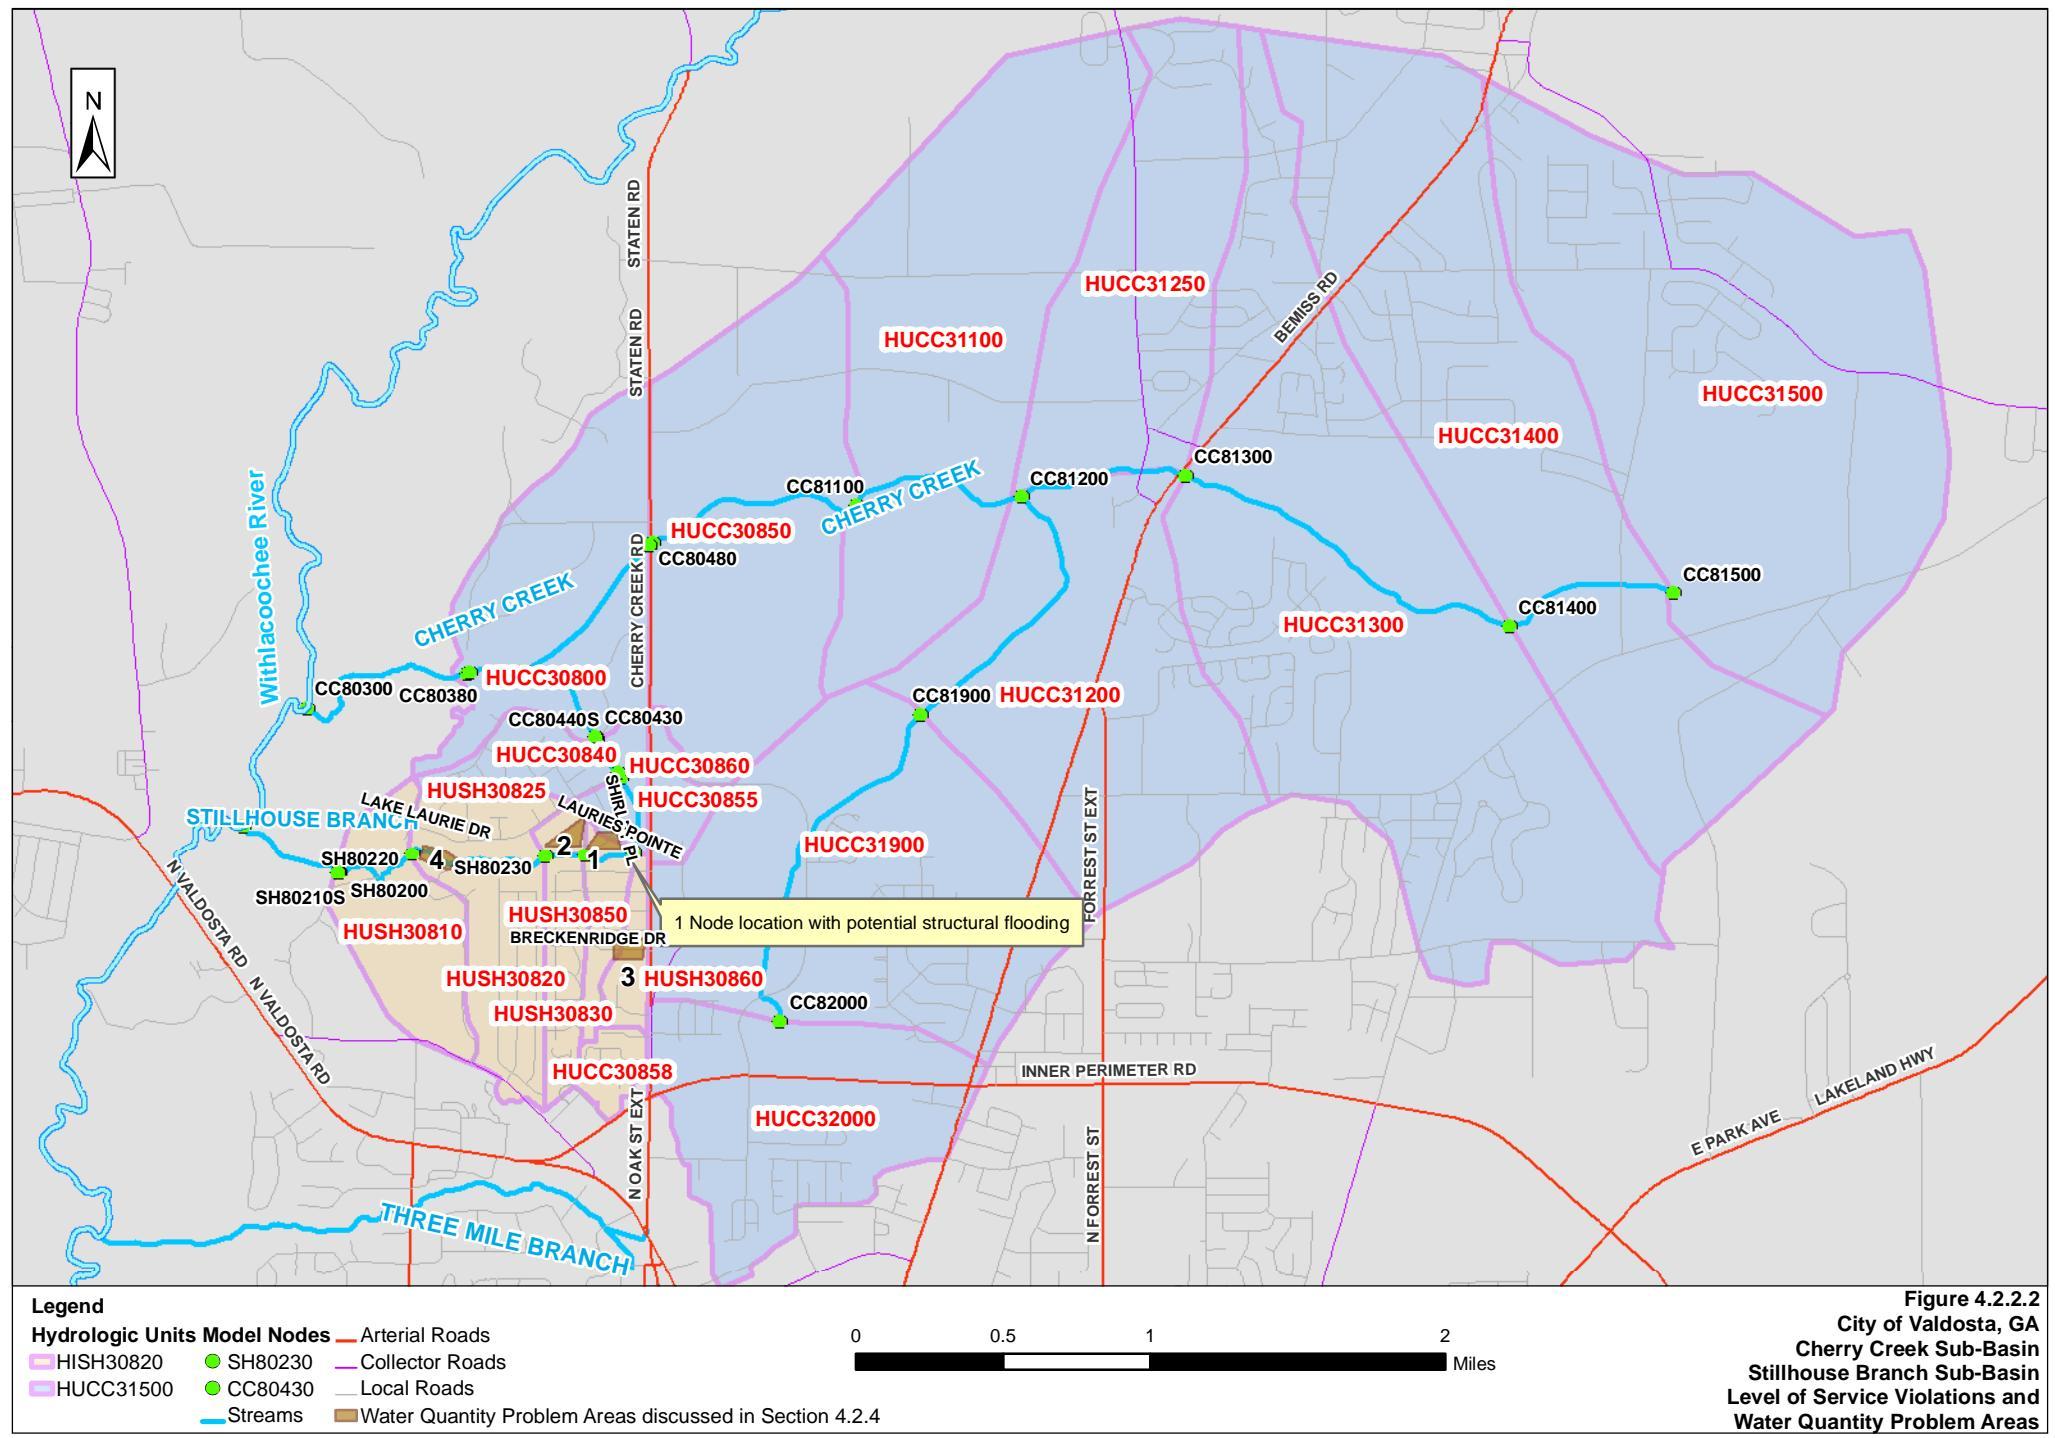
One location, as represented by model node, was identified in the Cherry Creek and Stillhouse Branch sub-basins for probable structural flooding for the 100-year event.

Please refer to **Figure 4.2.2.2** for a map of Level of Service violations for Cherry Creek and Stillhouse Branch sub-basin. Other water quantity problem areas are also shown on this figure.

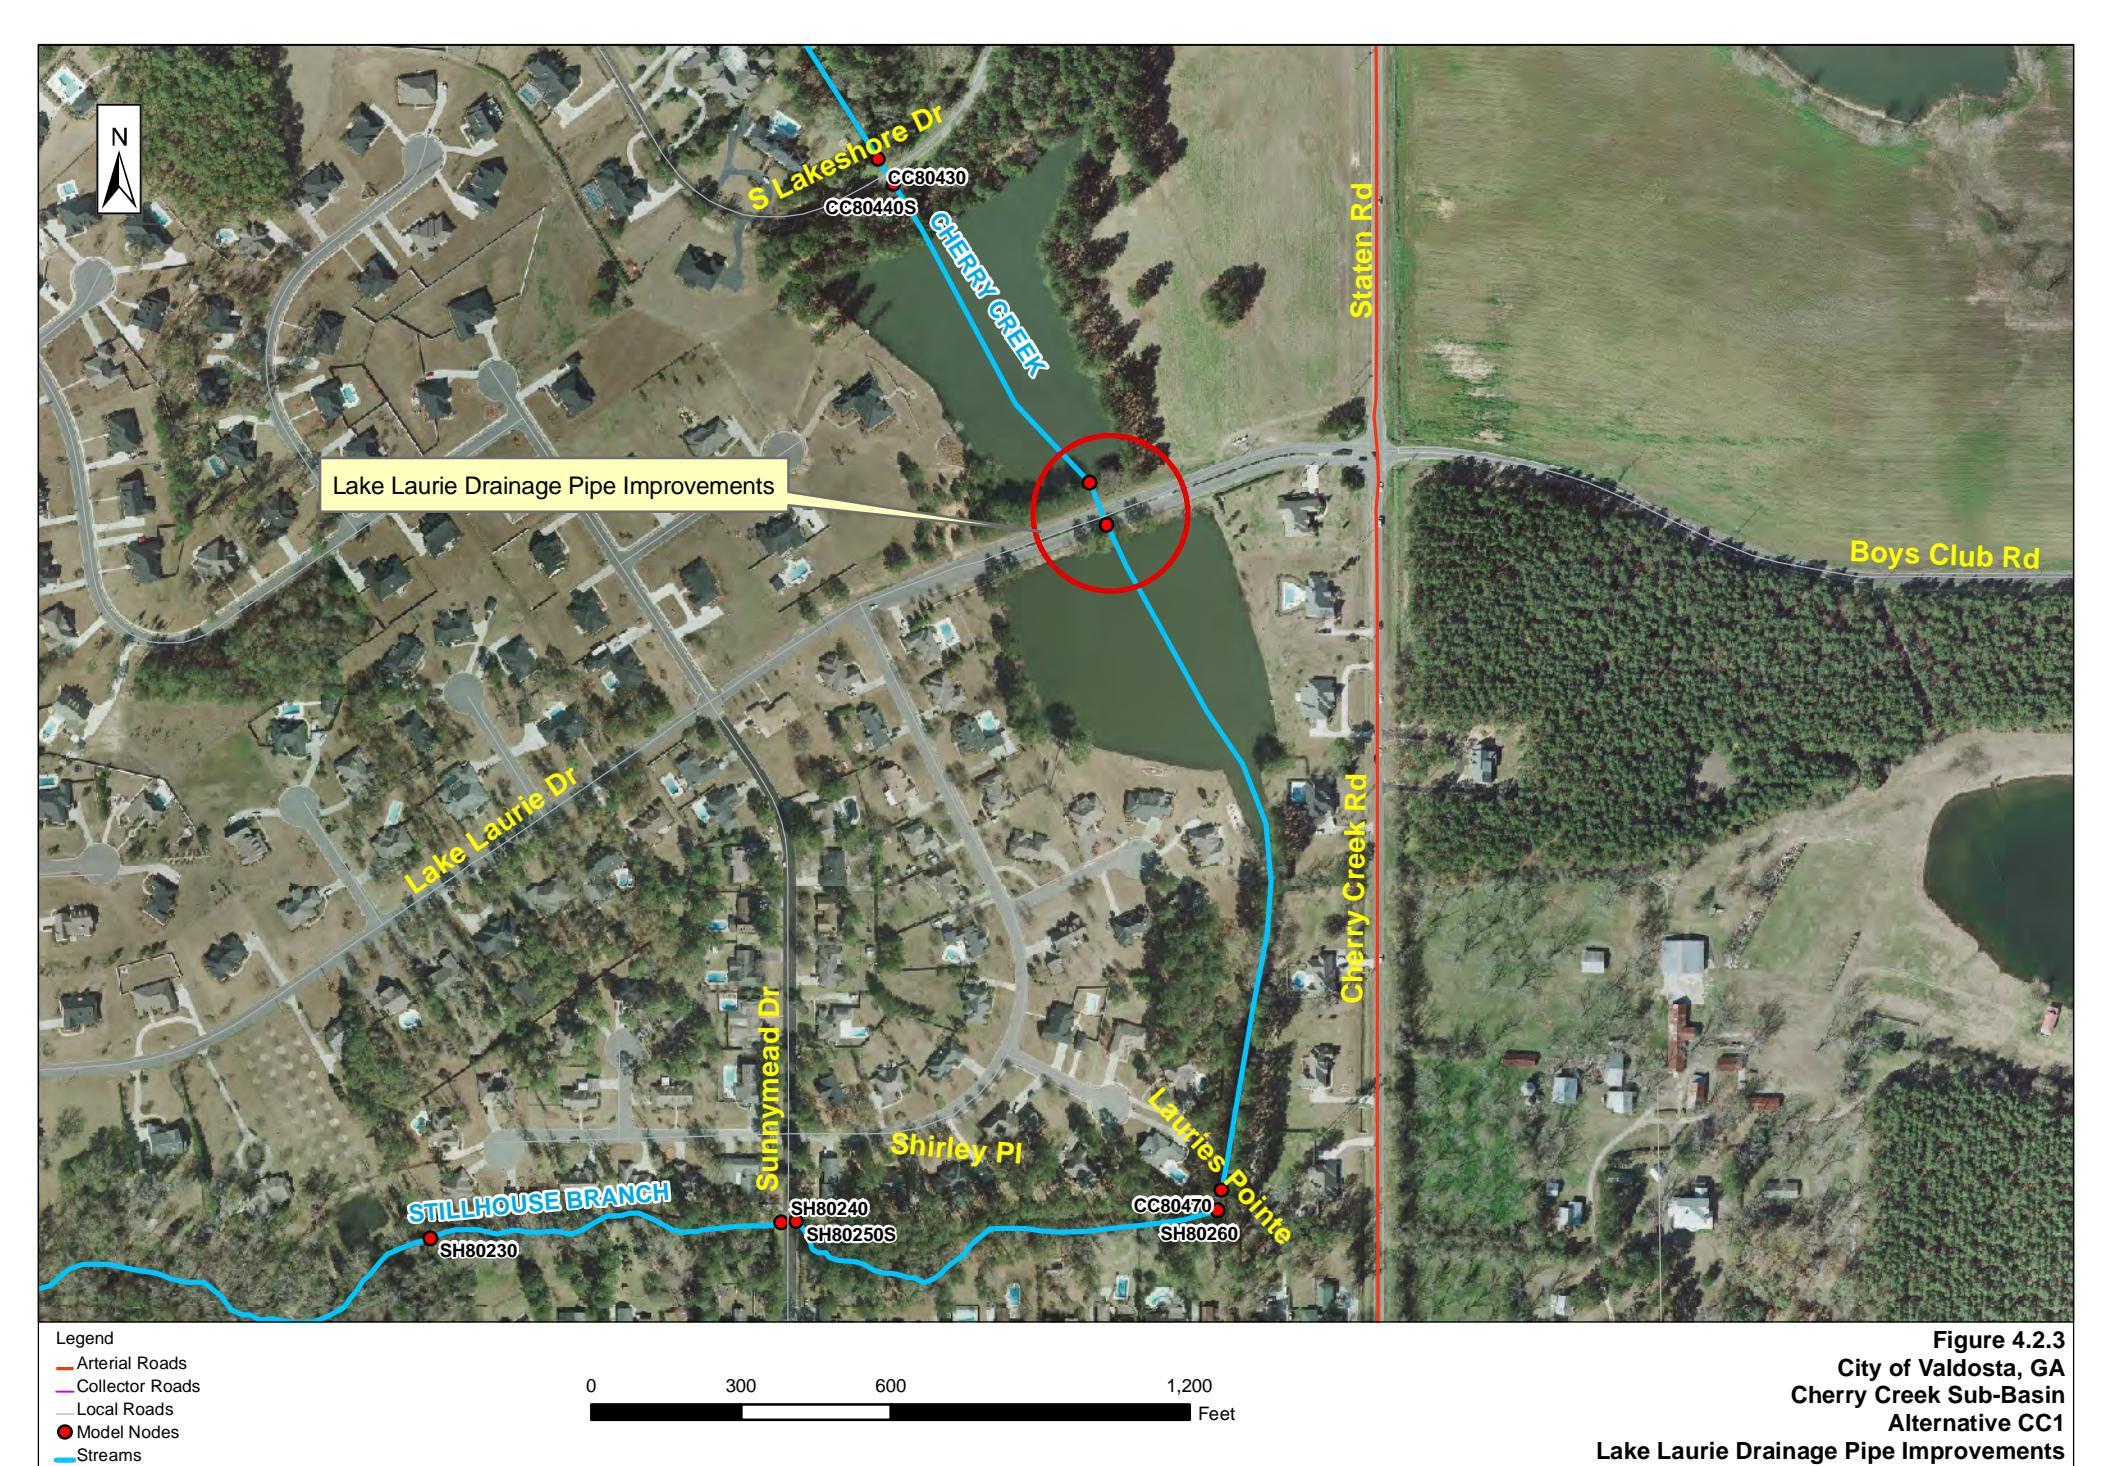
There have been instances of flooding in the houses near the location of Lake Laurie and the most upstream part of Stillhouse Branch. During high flow events, it has been noted in Lake Laurie, that instead of flowing north, there is a reversal of flow into the Stillhouse Branch. This has further increased issues of channel erosion, loss of trees and flooding in houses along Stillhouse Branch. There is a larger flow in Stillhouse Branch due to this flow reversal occurring at Lake Laurie.

This alternative addresses this drainage issue of Lake Laurie. The 18-inch Pipe and Riser in Lake Laurie is corroded and blocked and is not functioning. It is proposed to completely remove this pipe and construct a culvert with a weir as a control structure under Lake Laurie Drive. Dewatering and maintenance of traffic on Lake Laurie Drive are critical factors in this project.

This alternative shows benefits in terms of reduced flooding near the houses located near Lake Laurie and Stillhouse Branch. Reduced flows in Stillhouse Branch lead to lower velocities and therefore reduced channel erosion. **Figure 4.2.3** shows the location for this alternative. **Table 4.2.5** shows the conceptual costs estimates for this alternative.

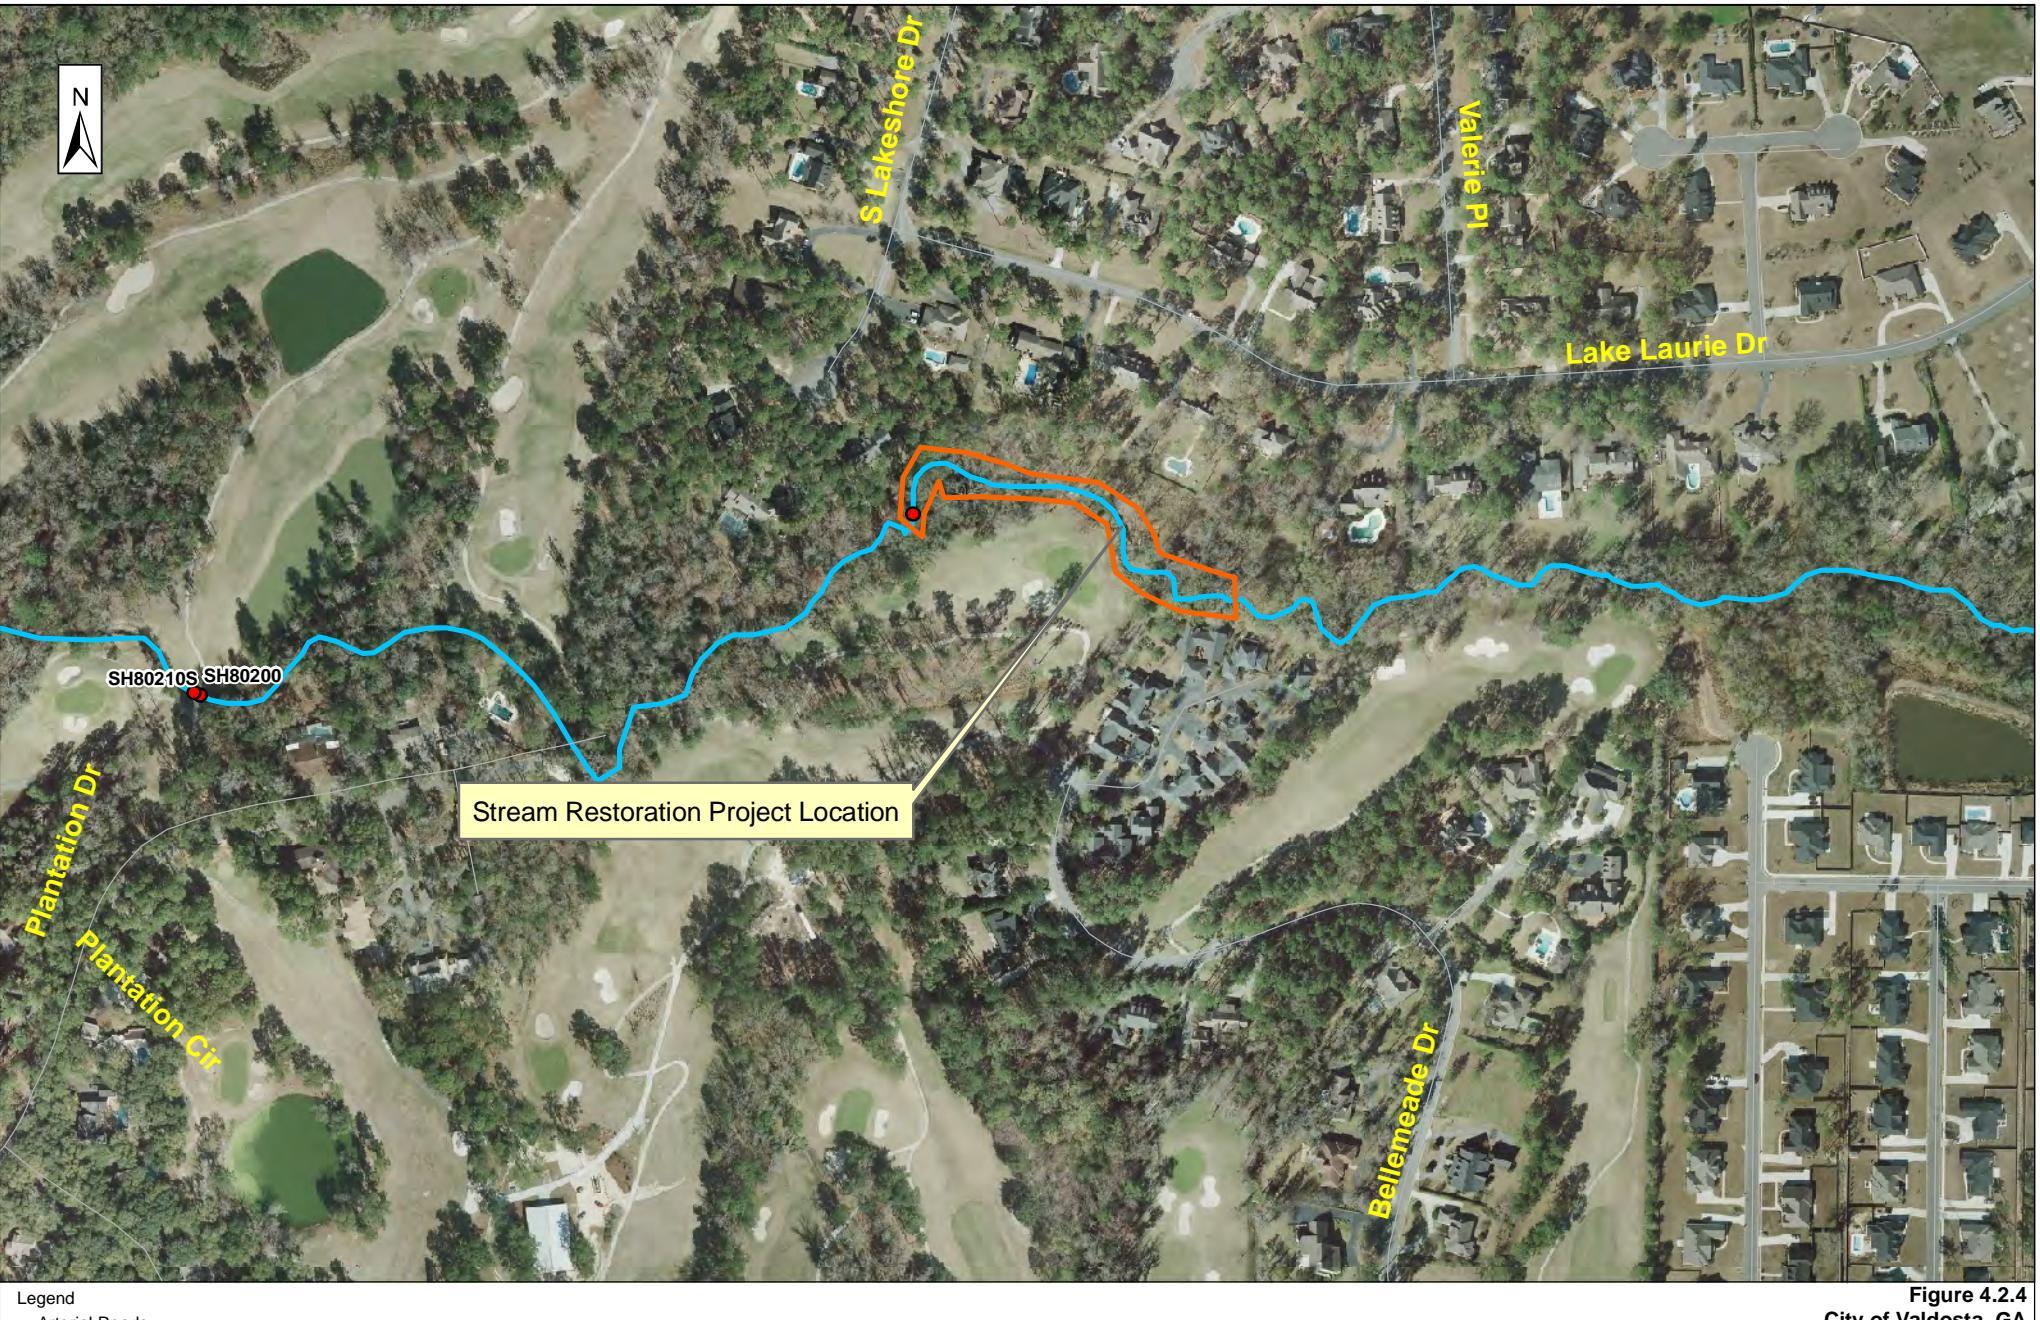
Legend					Figure 4.2.4
_Arterial Roads					City of Valdosta, GA
Collector Roads	0	250	500	1,000	Stillhouse Branch Sub-Basin
Local Roads				Feet	Alternative SH1
Model Nodes					Stillhouse Branch Stream Restoration
Streams					South of Lake Laurie Drive

Increased flows and high velocities in Stillhouse Branch have resulted in significant stream bank erosion. About 500 ft of channel between Lake Laurie Drive and Country Club Golf Course has undergone significant erosion and is causing a threat to existing trees and flooding in the backyards of houses along the stretch. There have been several instances of water rising out of the channel and into the backyards.

Upon field investigation of this location, it is proposed to restore this section of the stream using some method of stream restoration such as gabions, rip rap, etc. This project if implemented will protect the stream from further erosion, stabilize the trees, and also protect private property from future flooding. An access easement to the project site during construction and future maintenance would need to be acquired. The project will have partial impact on about 4-5 parcels (private property owners). **Figure 4.2.4** shows the location for the stream restoration project along with access easement. **Table 4.2.6** shows the conceptual costs estimates for this alternative.

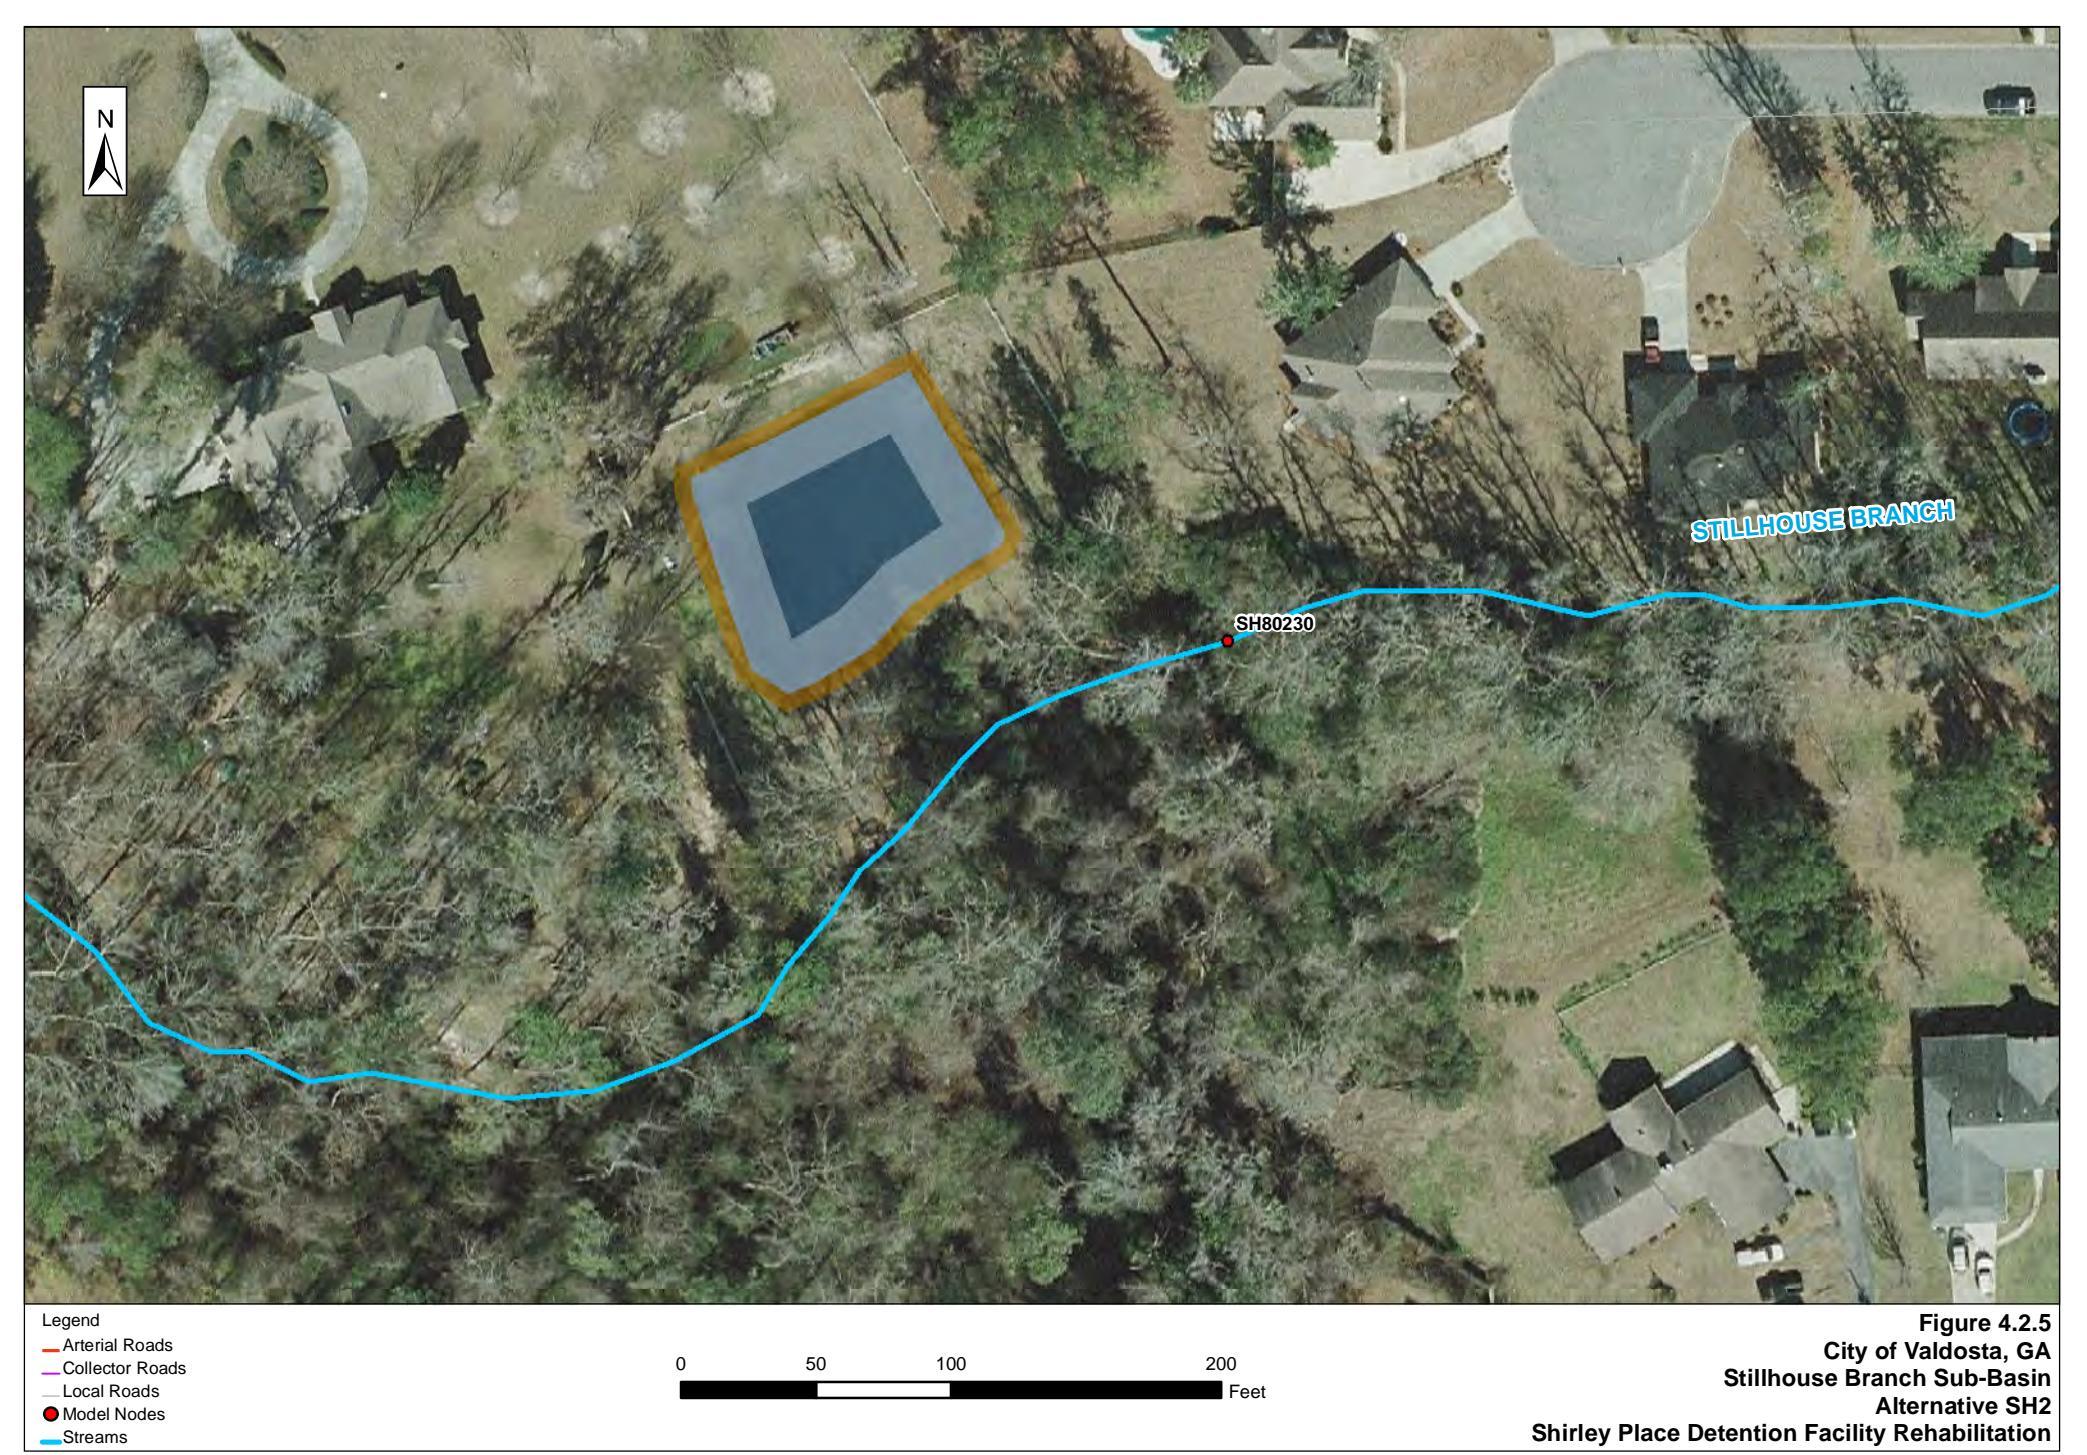
A small detention pond already exists at this location near Shirley Place in the Stillhouse Branch sub-basin. The inlet to this pond is no longer functioning and the pond is filled up and does not provide any detention benefits to the area. Recently there have been several flooding instances just upstream of this pond, in houses located on Shirley Place. Significant channel erosion due to flooding has caused loss of trees at this location.

CDM proposes to rehabilitate this pond by constructing appropriate inlet control structures to the detention pond, routing the street stormwater drains to the pond, and excavating the pond to provide about 4 Ac-ft of live storage. This pond, once properly rehabilitated, will reduce flooding in houses located on Shirley Place and also protect the existing trees in the vicinity by preventing stream erosion. **Figure 4.2.5** shows the location of the Shirley Place detention pond. **Table 4.2.7** shows the conceptual costs estimates for this alternative.
