City of Valdosta

Sanitary Sewer Condition Assessment and Rehabilitation Program Plan

Condition and Criticality Report

January 2010

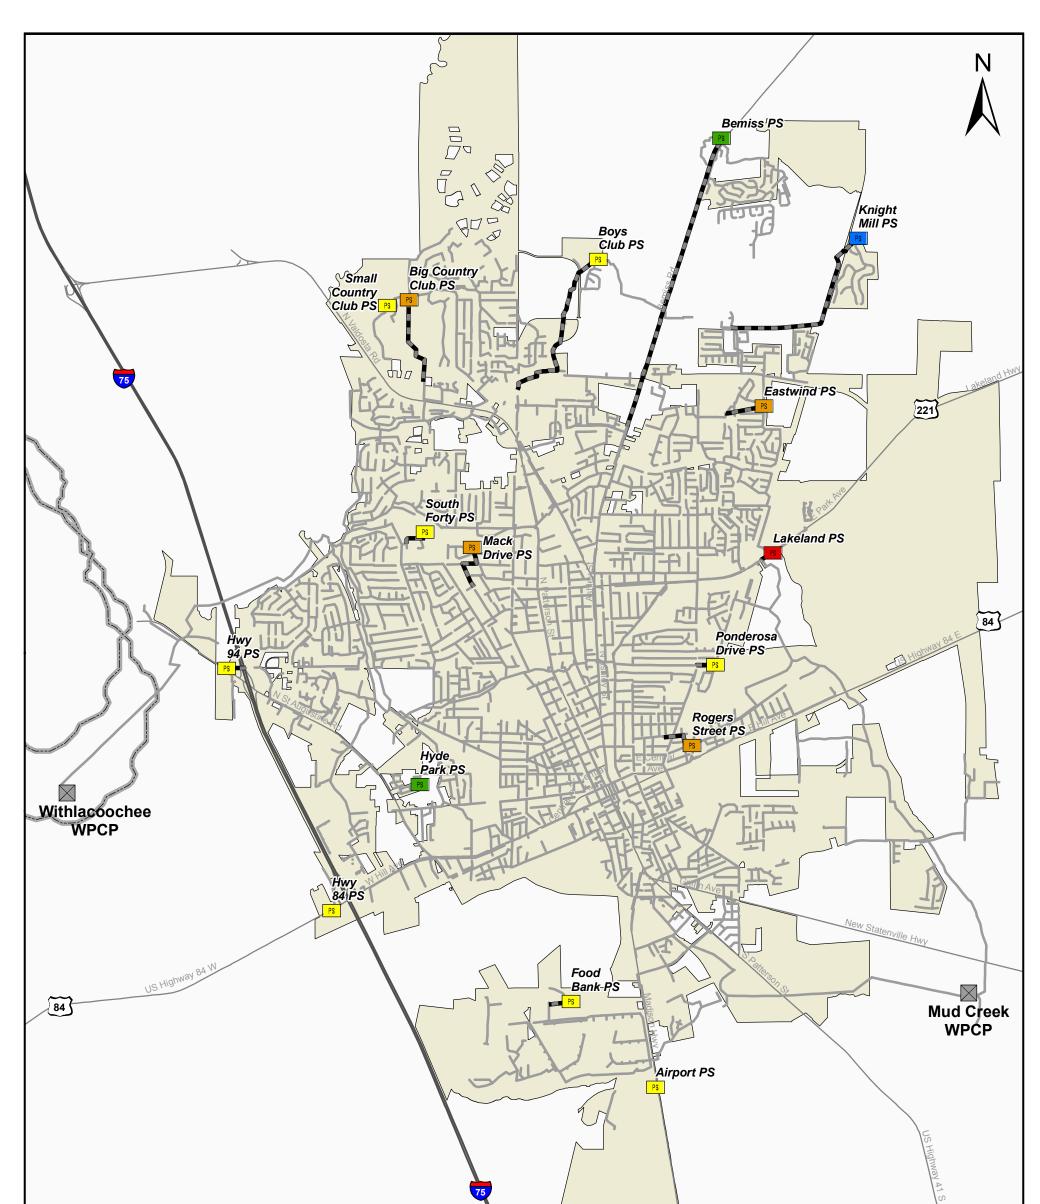
Figure 2-7 City of Valdosta Sewer Collection System Structural Rating for Pump Stations

CDM performed site visits at the City's pump stations in December 2007. As part of the site visits, general information, overall structural condition, and concerns at each pump station were reviewed with City staff. This information was used to assign a structural condition level at each pump station. Levels are site-specific to each station. **Table 2-10** summarizes the general criteria used to apply levels to pump stations for the structural condition factor. Structural condition levels are also shown in **Figure 2-7**.

Description	Level	Number of Pump Stations
Excellent condition; new or like-new station	1	1
Very good condition; some recent improvements have been made to the station	2	2
Good condition; station does not experience operational issues	3	8
Fair condition; some concerns but pump station not in imminent danger of failure; some improvements needed	4	4
Poor condition causing some important elements not to function	5	1
Unknown; not inspected	3.1	0

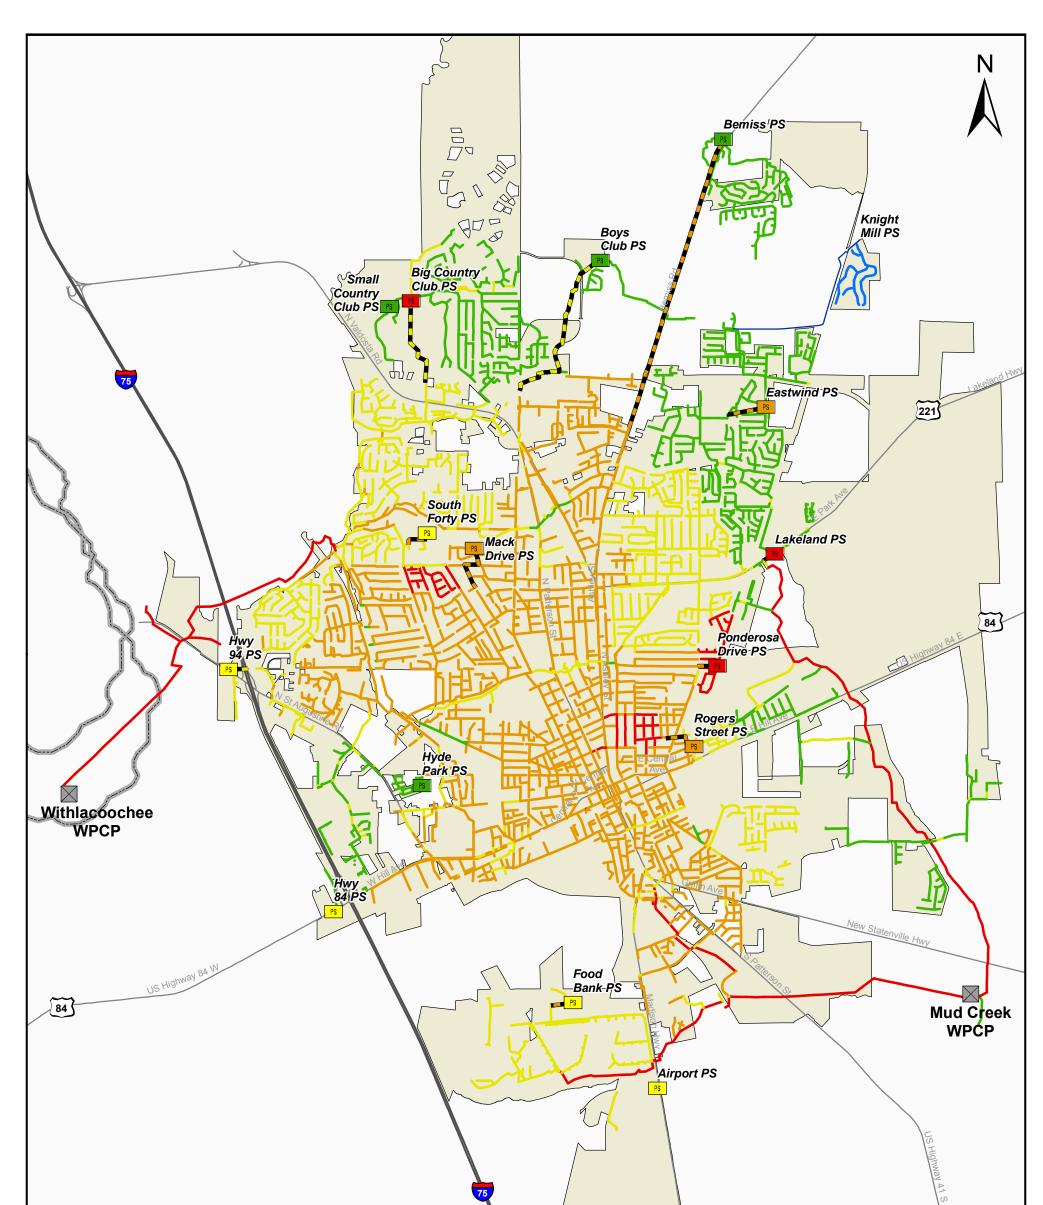
Figure 2-14 City of Valdosta Sewer Collection System Condition Rating

Overall condition and criticality ratings were calculated for each gravity sewer, force main, and pump station. Ratings were rounded to the nearest whole number. **Figure 2-14** shows the final condition rating for each asset. For gravity sewers, the assets that are suspected to be in the worst condition (orange and red on the figure) are generally the older VCP pipes with some known concerns. These pipes are mainly located in the central portion of the City and along the Knights Creek, Mud Creek, and Withlacoochee outfalls.

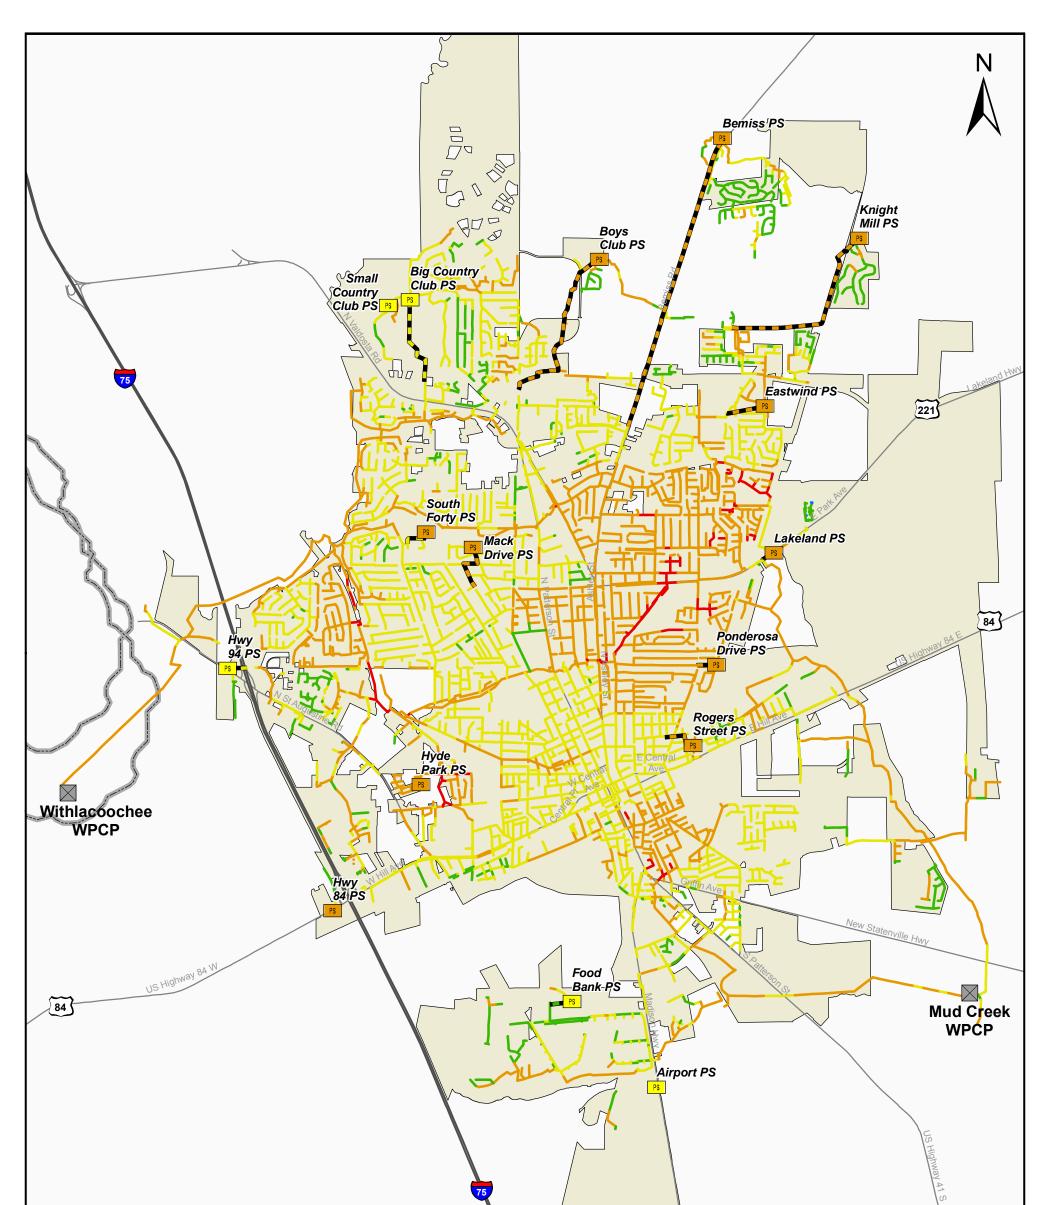
Figure 2-15 City of Valdosta Sewer Collection System Criticality Rating

Figure 2-15 shows the final criticality rating for each asset. The assets that were identified as being most critical if a failure occurred are those that convey the largest amount of flow; are closest to water, roads, and densely populated areas; and are downstream of large water/sewer users.

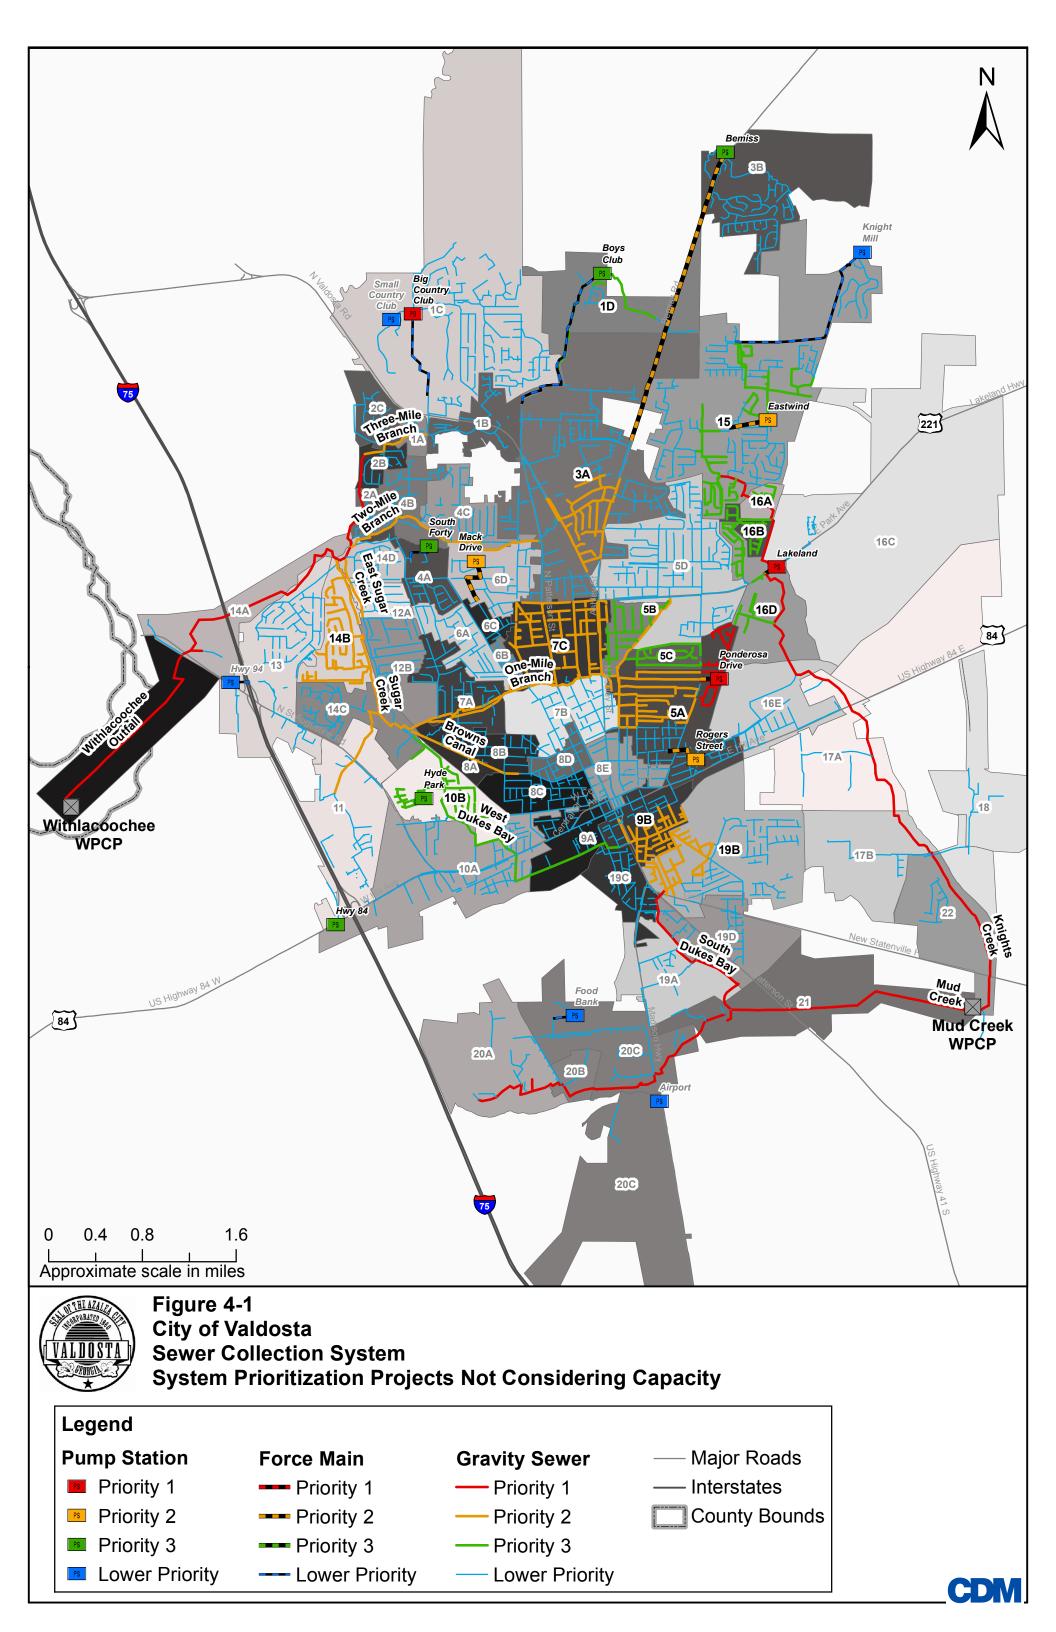
The Withlacoochee outfall flows from the junction of Sugar Creek and Two Mile Branch to the Withlacoochee WPCP and contains approximately 19,000 feet of 42- to 54-inch diameter gravity sewer and 40 manholes. Sections of the outfall cross under standing water, and access to the outfall is difficult. Flow recorded at the Withlacoochee WPCP effluent meter and levels recorded by a temporary meter on the trunk sewer were elevated for 2 weeks following the February 22, 2008 storm event.

Flows recorded by meters installed on branch sewers upstream did not show the same elevated flow pattern, suggesting that the flow was coming in through the outfall.

Further investigation is recommended to verify the actual structural condition of this outfall. The flow monitoring data shows that the 42- to 54-inch Withlacoochee outfall is approximately 60-percent full during average dry-weather conditions and over 30-percent full during minimum nighttime conditions. Thus, CDM recommends using multi-sensor robotic investigations such as those available from Red Zone Technologies for pipeline condition assessment of this outfall. Red Zone Robotic technology allows collection of CCTV, sonar, and laser profiling, all, in a single pass.
